BUILDING A NEW SPAR FOR ENDEAVOUR

Storm damage to the museum's HMB *Endeavour* replica during a recent trip to Hobart necessitated the construction of a new spritsail yard. *Endeavour's* first mate, **Anthony Longhurst**, details the process.

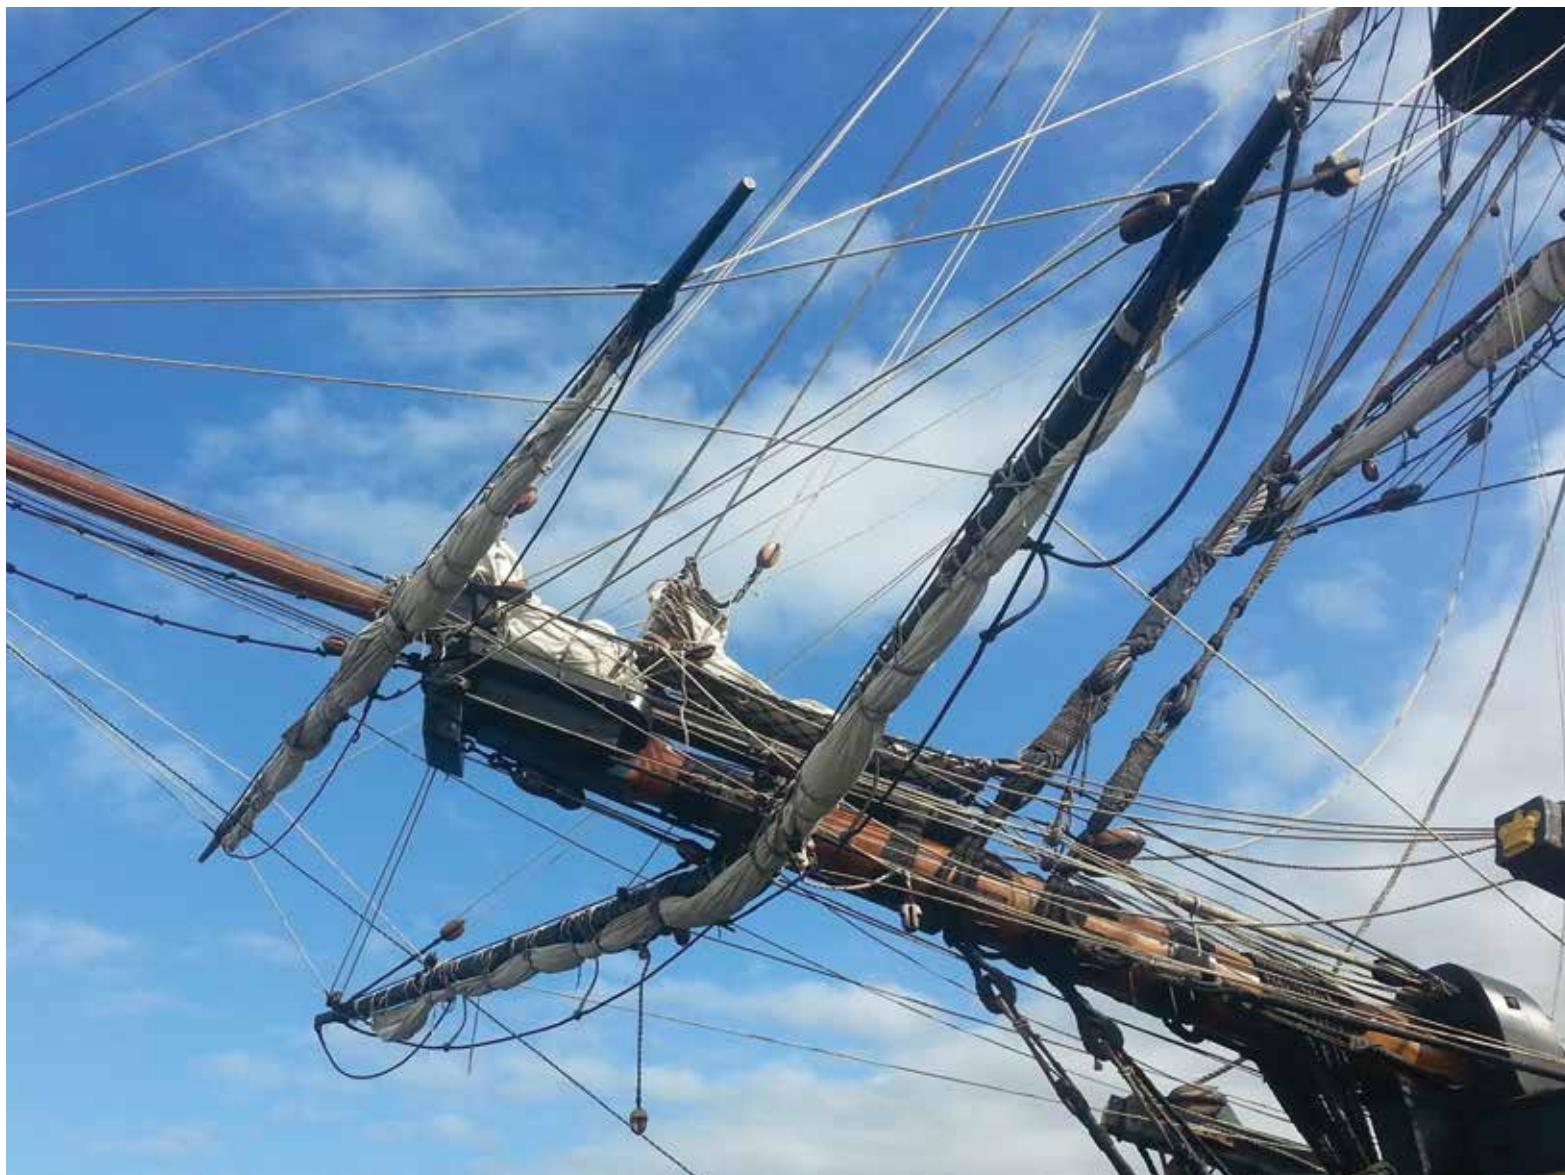
The broken spritsail yard.
All photographs by Anthony Longhurst/
ANMM unless otherwise stated

After motoring for several days and making a slow 160 nautical miles to the south, *Endeavour* rode over a large wave and pitched into a deep trough, burying her bowsprit and jibboom. The spritsail yard that is attached beneath the bowsprit did not survive the pressure, breaking in two at its centre. Attached to the spritsail yard are the jibboom guys, which provide important downward support for the jibboom and add support to the fore topgallant mast. With the loss of this support, pushing the ship into a heavy head sea for at least another four days – let alone the remaining 1,000-plus nautical miles of planned voyaging ahead – was deemed too risky, even with the jury-rigged martingale that we put in place shortly after the yard broke.

We decided it would be easier and faster to replace the broken yard rather than

repair it, and chose Douglas fir (Oregon) for the task. All of the spars, decking and topside planking on *Endeavour* are Oregon. This timber is used because it has good flexibility, is relatively lightweight (approximately 560 kilograms per cubic metre) and is fairly easy to source. The timber for the replacement yard was of exceptional quality, having a very tight, straight grain with no knots in lengths of up to six metres. In all, 80 lineal metres of timber were bought to be glued (laminated) together to build the new yard, rather than trying to find a single straight tree to shape it from. Laminated spars are also stronger than those made from a single piece.

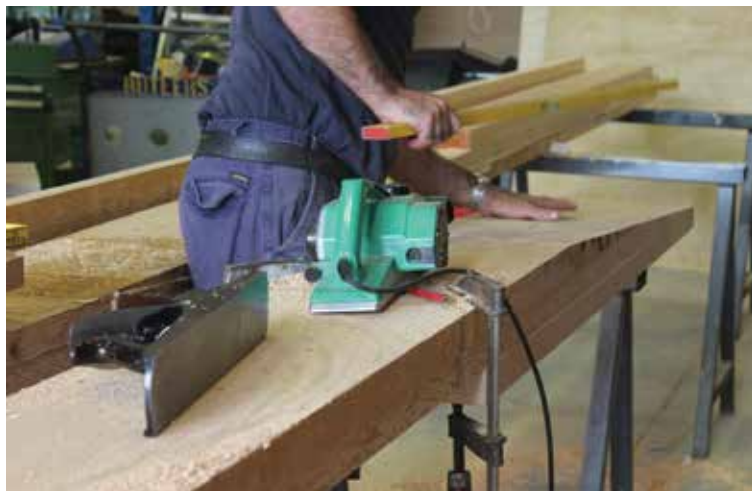
- 01 Cutting the scarf joints.
Photograph Eden Alley-Porter/ANMM
- 02 The team glue up the planks, after first roughing up the timber to give greater grip.
Photograph Mark Edwards/ANMM
- 03 The clamps go on.
Photograph Eden Ally-Porter/ANMM
- 04 The yard is cut and planed into a tapered square.
- 05 Planing to make the yard 16-sided.
- 06 Dressing the yard.
- 07 The completed yard on the ship.

We had a great team that was made up of Fleet staff and volunteers from the museum plus some assistance from the Sydney Heritage Fleet. To make the yard, the planks (or deals) of Oregon were dressed to a uniform thickness, all glued faces were roughed up to ensure the glue would adhere properly and 12:1 scarf joints were cut so that the yard's overall length could be achieved by joining shorter lengths together without losing any strength. Six layers of timber were glued together with epoxy to make a square section of laminated timber 12 metres long. All of the scarf joints in each of these laminated layers were staggered so that no two joints were located in the same area, to avoid creating a potential weak point.
